**TRANSPORTATION SCIENCES CENTER
ACCIDENT RESEARCH GROUP**

CALSPAN ON-SITE AIR BAG/CHILD PASSENGER FATALITY INVESTIGATION
CALSPAN CASE NO. - ~~CA 94-43~~ CA 96 08
VEHICLE - 1995 HYUNDAI ACCENT
LOCATION - FLORIDA
CRASH DATE - ~~██████~~ 1996

16. <i>Abstract</i> <p>This on-site air bag deployment crash focused on the injury mechanisms for the fatal injuries sustained by a 3 month male passenger who was restrained in a rearward-facing Evenflo On-My-Way child restraint in the right front position of a 1995 Hyundai Accent. The driver of the vehicle was assisting the mother of the infant by following her to a auto repair service center for repairs to the mother's vehicle. Due to a leaky exhaust system, the infant's mother allowed the Hyundai driver to transport the infant in her vehicle and not expose the child to the potentially hazardous exhaust fumes. A third party assisted in the placement of the infant restraint in the right front position of the Hyundai. None of the adults were aware of the risks associated with the risks of rearward-facing child restraints and the deployment of passenger side air bag systems.</p> <p>En route to the service center, the driver of the Hyundai initi

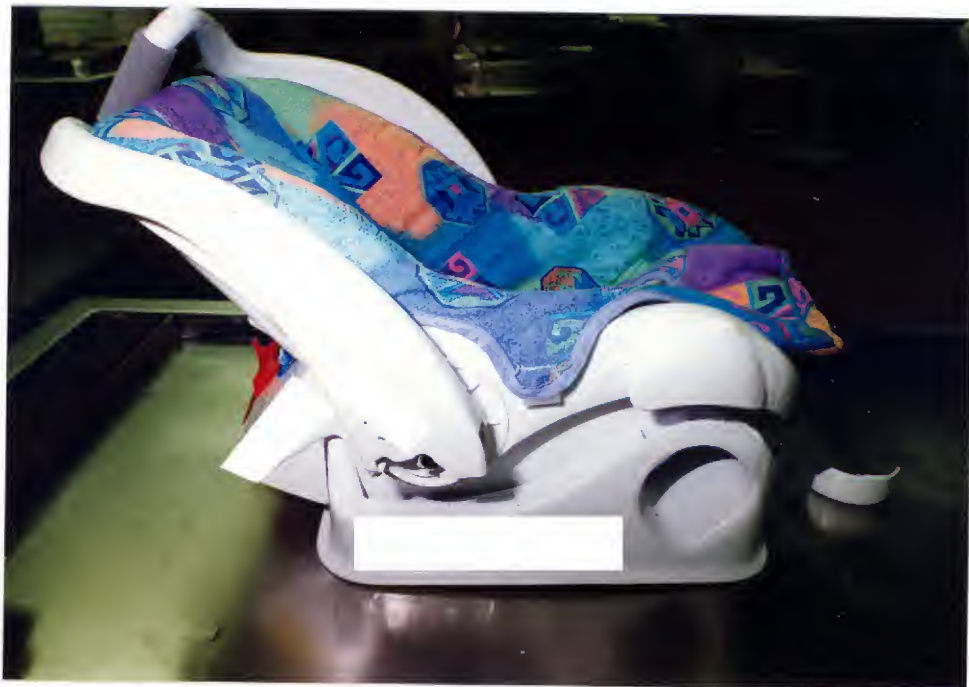
72. Right side view of the restraint.

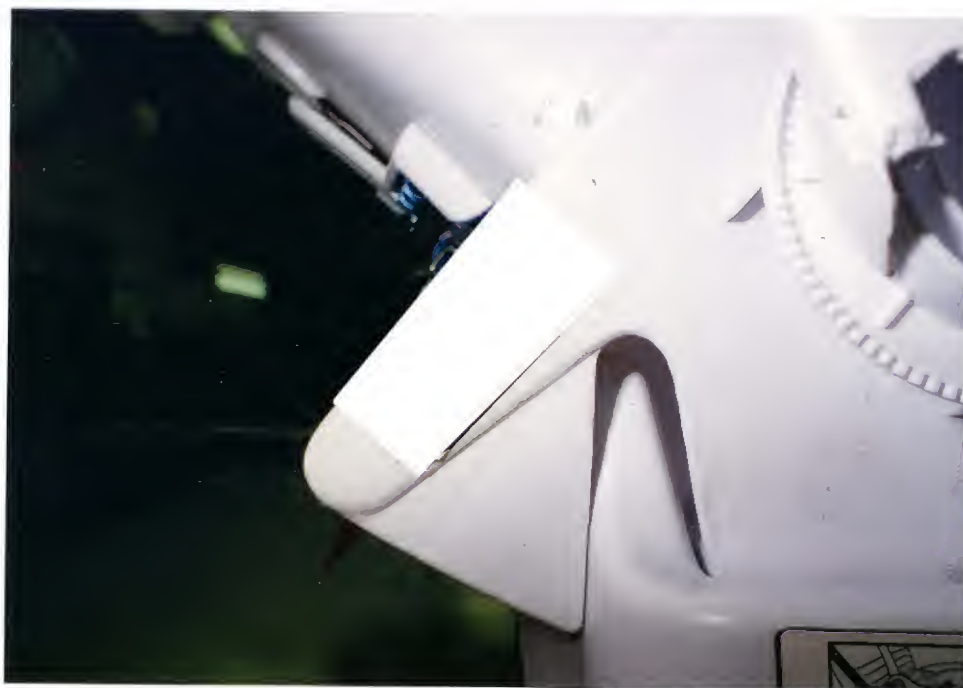
74. Warning label advising against placing the restraint in the right front of a vehicle equipped with a passenger side air bag.

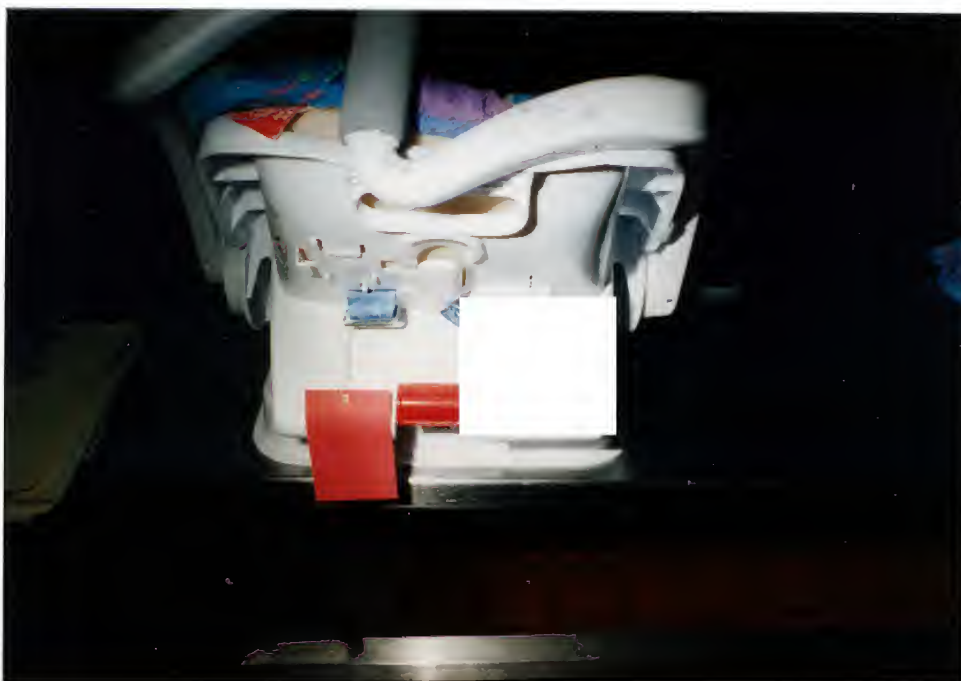
78. Off-set handle configuration in its position at time of deployment.

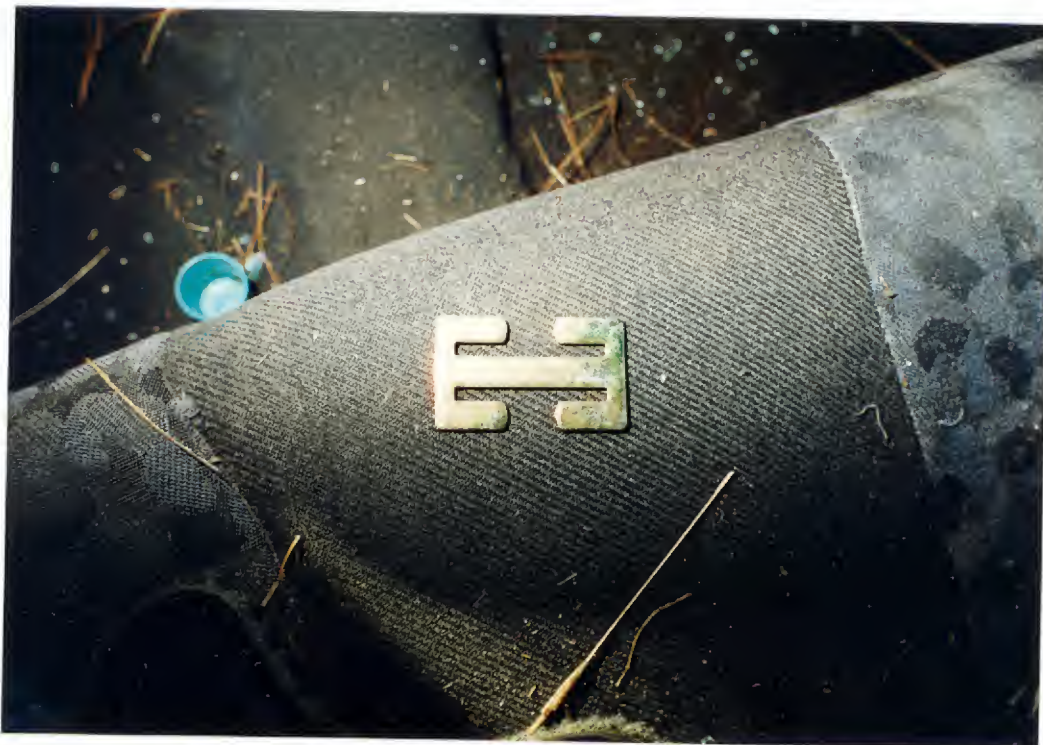
83. Locking clip supplied with infant restraint found on rear seat cushion; unknown if used at time of crash.
